DEPARTMENT OF TRANSPORTATION**DIVISION OF ENGINEERING SERVICES**

Quality Assurance and Source Inspection

Contract #: 04-0120F4Cty: SF/ALA Rte: 80 PM: 13.2/13.9File #: 1.28**WELDING INSPECTION REPORT****Resident Engineer:**Siegenthaler, Peter**Address:** 333 Burma Road**City:** Oakland, CA 94607**Report No:** WIR-023454**Date Inspected:** 05-May-2011**Project Name:** SAS Superstructure**OSM Arrival Time:** 700**Prime Contractor:** American Bridge/Fluor Enterprises, a JV**OSM Departure Time:** 1530**Contractor:** American Bridge/Fluor Enterprises, a JV**Location:** Job Site**CWI Name:** Pat Swain**CWI Present:** Yes No**Inspected CWI report:** Yes No N/A**Rod Oven in Use:** Yes No N/A**Electrode to specification:** Yes No N/A**Weld Procedures Followed:** Yes No N/A**Qualified Welders:** Yes No N/A**Verified Joint Fit-up:** Yes No N/A**Approved Drawings:** Yes No N/A**Approved WPS:** Yes No N/A**Delayed / Cancelled:** Yes No N/A**Bridge No:** 34-0006**Component:** Tower**Summary of Items Observed:**

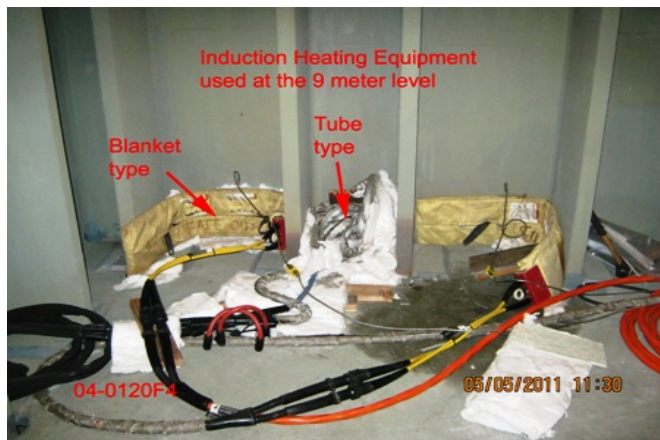
This QA Inspector observed ABF personnel appeared to be having issues with the induction heating equipment being used to preheat the material. This QA Inspector observed ABF personnel setting up the preheat equipment at approximately 0700 hours but, it was just after 0900 hours before the minimum preheat temperature of 325°F was obtained and welding was started. See photo below of the typical blanket and tube type induction heating equipment and set up being used.
